SAFETY EVALUATION OF "PHOTO FINISH"

RESEARCH AND TECHNOLOGY DEPARTMENT

3 NOVEMBER 1981

REPORT DOCUMENTATION	PAGE	READ INSTRUCTIONS BEFORE COMPLETING FORM
I. REPORT NUMBER	2. GOVT ACCESSION NO.	3 RECIPIENT'S CATALOG NUMBER
NSWC TR 81-327	AD 1130 203

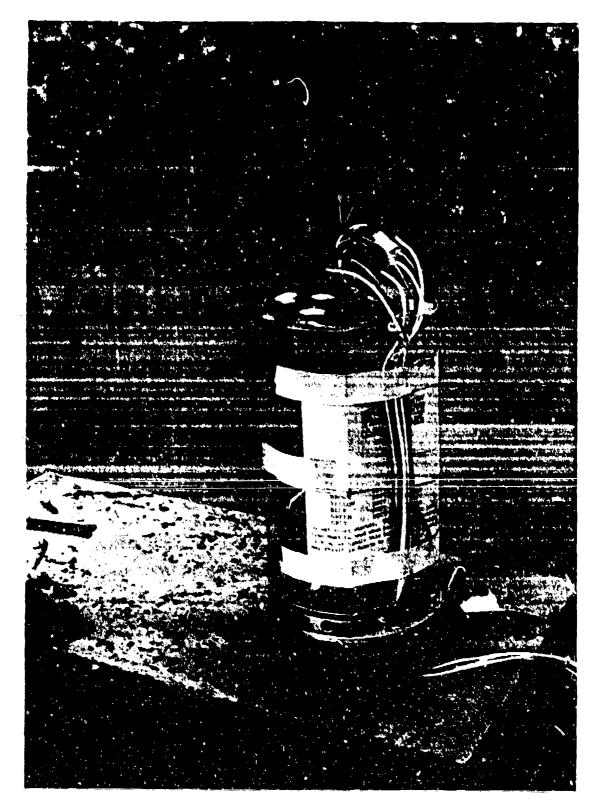
FIGURE 2 PHOTOGRAPH OF BATTERY PACKAGE. THE POWER SUPPLIES USED TO POWER "PHOTO FINISH" ARE CONTAINED INSIDE THIS PACKAGE.
